LIFE10 NAT/DK/000102

FINAL Report
Covering the project activities from 01/09/2011 to 30/06/2020
20/10/2020

Lille Vildmose
Restoration of active raised bog – Lille Vildmose

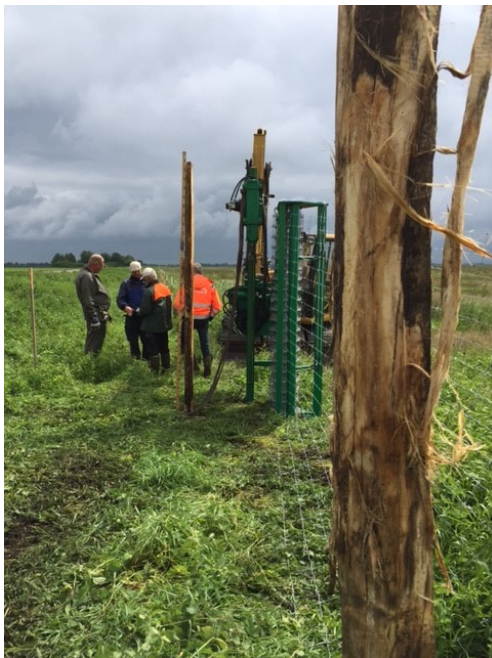
Fence is raised

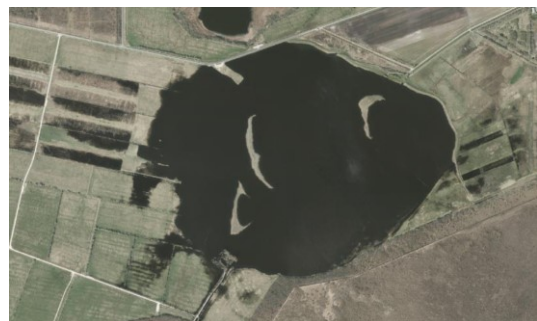
Location after restoring the lake (2019)

established didn't have the grass covering necessary for withstanding the exposure to the increased water level. That resulted in erosion damages to that part of the dyke. Since the dyke is build up around a watertight plastic membrane, there was no risk that the water uncontrolled would run out of the lake. However, an effort was made to prevent further damages to the dyke by covering the dyke with straw mats and by lowering the water level in the lake.

The Nature Agency and the Aage V. Jensen Naturfond will inspect the dike regularly over the next years to follow the condition of the dike and the grass cover.

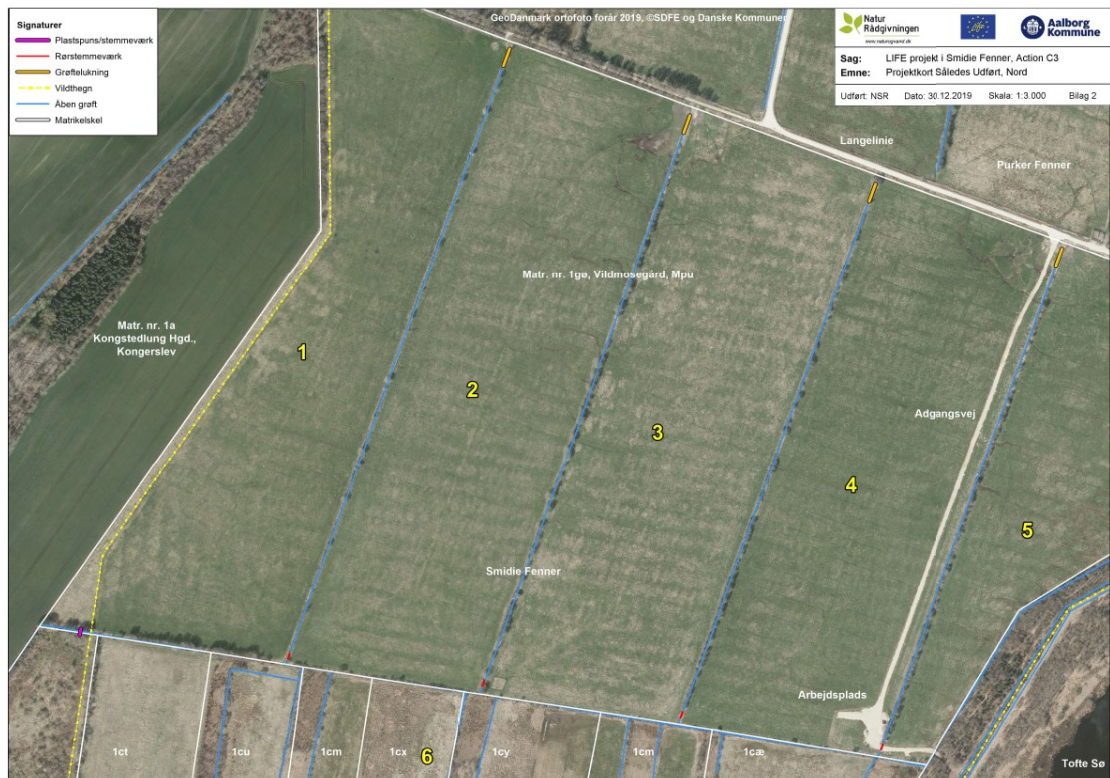
In the northern part of Smidie Fenner the main activities have been to close ditches and prepare for a raise in the water level. The map below shows where ditches have been closed and drain pipes disconnected.

Closure of ditches (yellow markings)

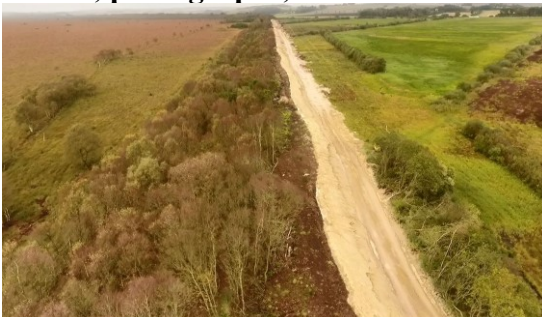
Transect of membrane under construction

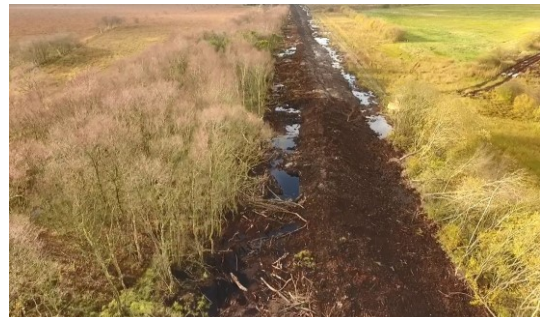
Same transect after construction

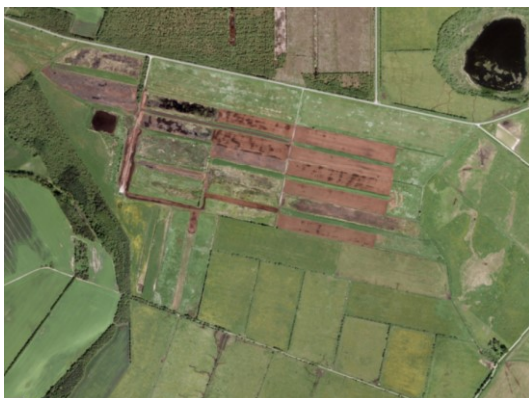
Summer 2010

However, aerial photos of Purker Fenner reveals the changes in visible water level before and after the construction work indicating that these objectives have been achieved.

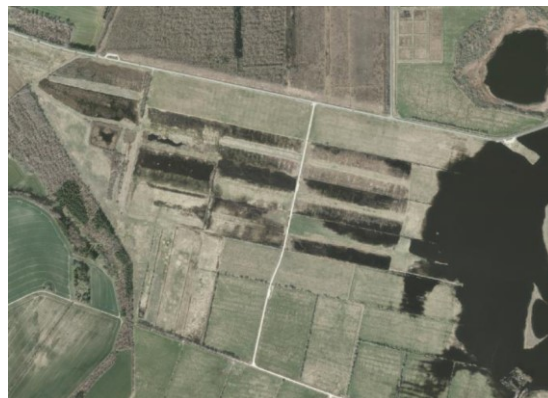
Spring 2019. Dark areas is open water

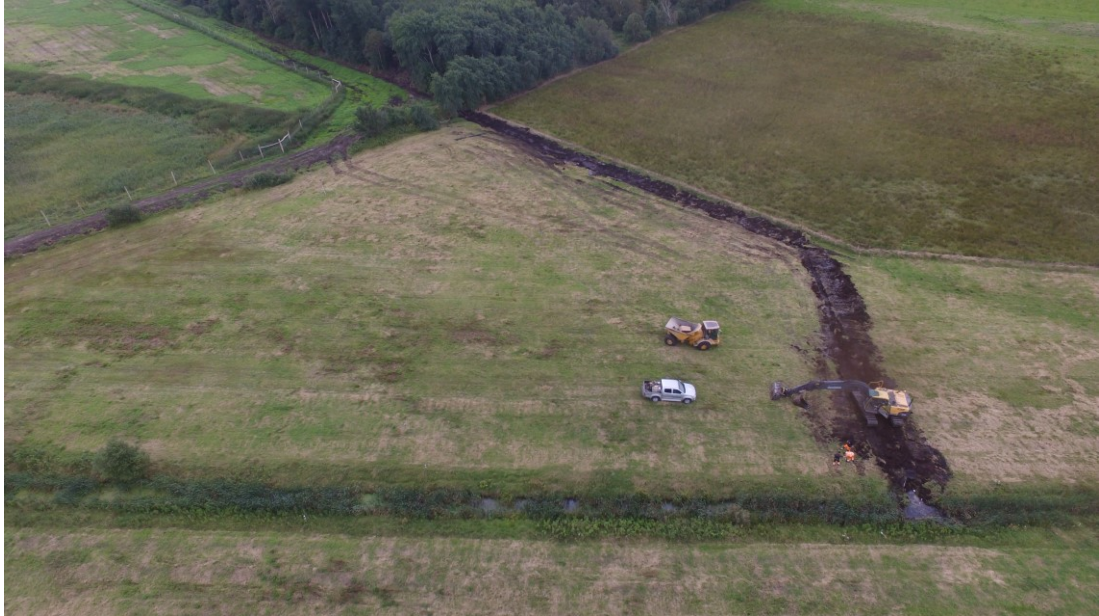
Construction of watertight membrane on north-western border of Purker Fenner.

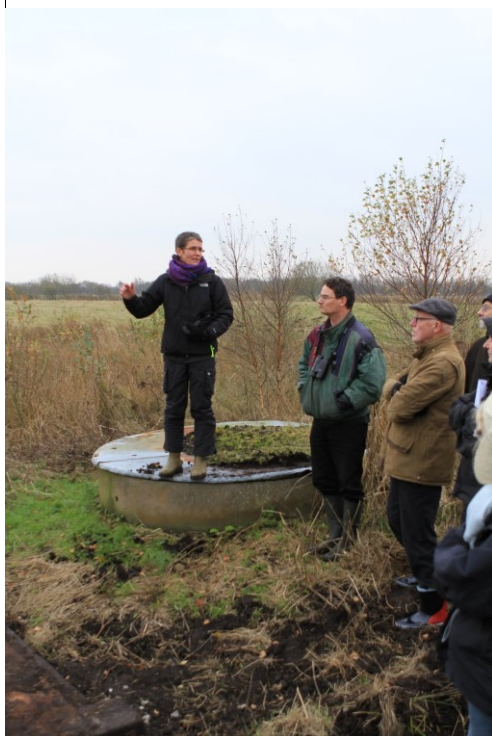
Old pumping station

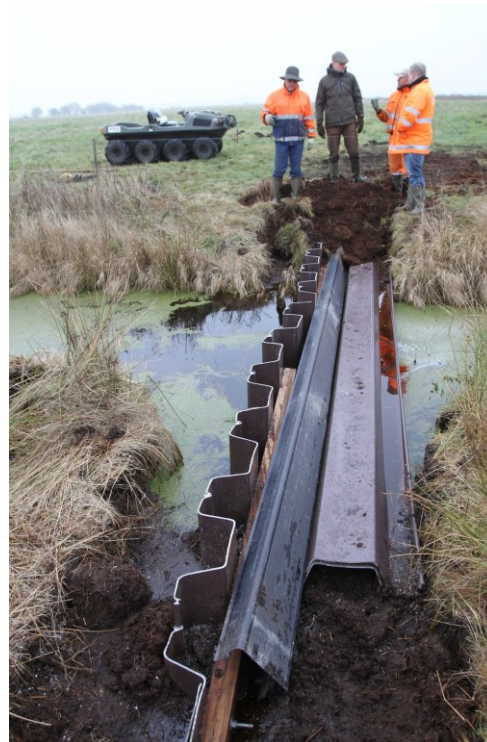
In order to raise the water level in Mou Fenner a pump has been dismantled and replaced by a weir to regulate the water level.

New weir replacing the pump

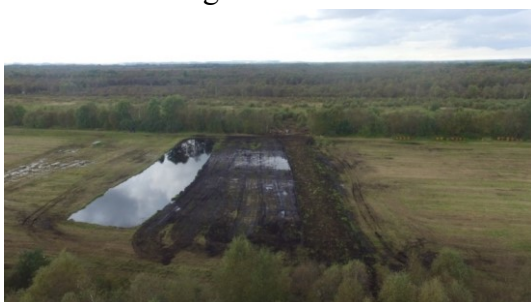
Photos here below shows the construction of one of the smaller dams in Paraplymosen. Peat to be used as topsoil on the dam was collected locally creating small deeper pools. The photo to the right shows the construction of the long watertight membrane along the main road.

Removal of topsoil created small ponds

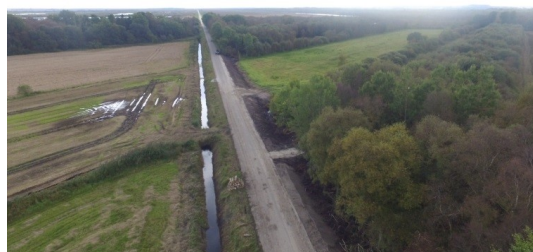
Construction of watertight membrane

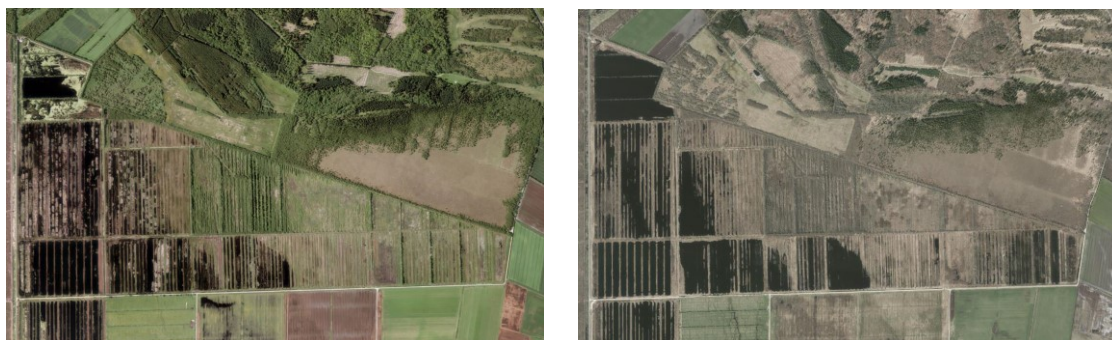
Aerial photo from 2010 and 2019 showing the resulting raised water level

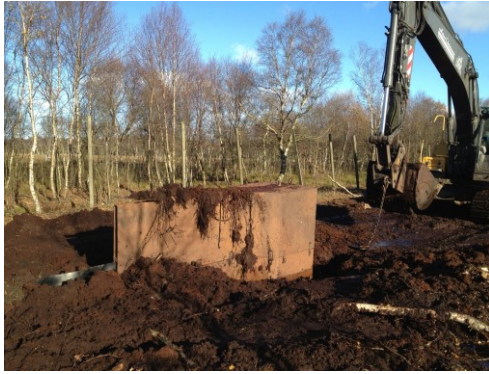
Box to control PE roll

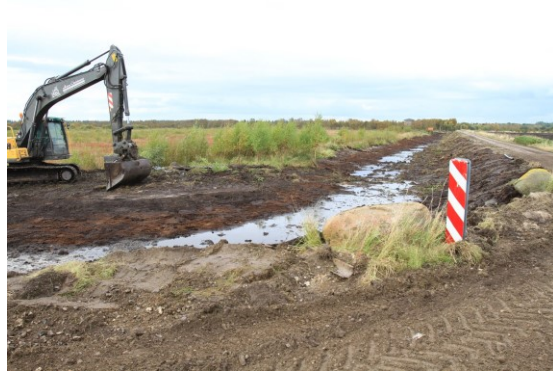
This action was the first in the Life project to use bentonite as a watertight membrane. However, bentonite is often used in construction of landfill sites to prevent seepage from the landfill into the groundwater.

Bentonite membrane is in place

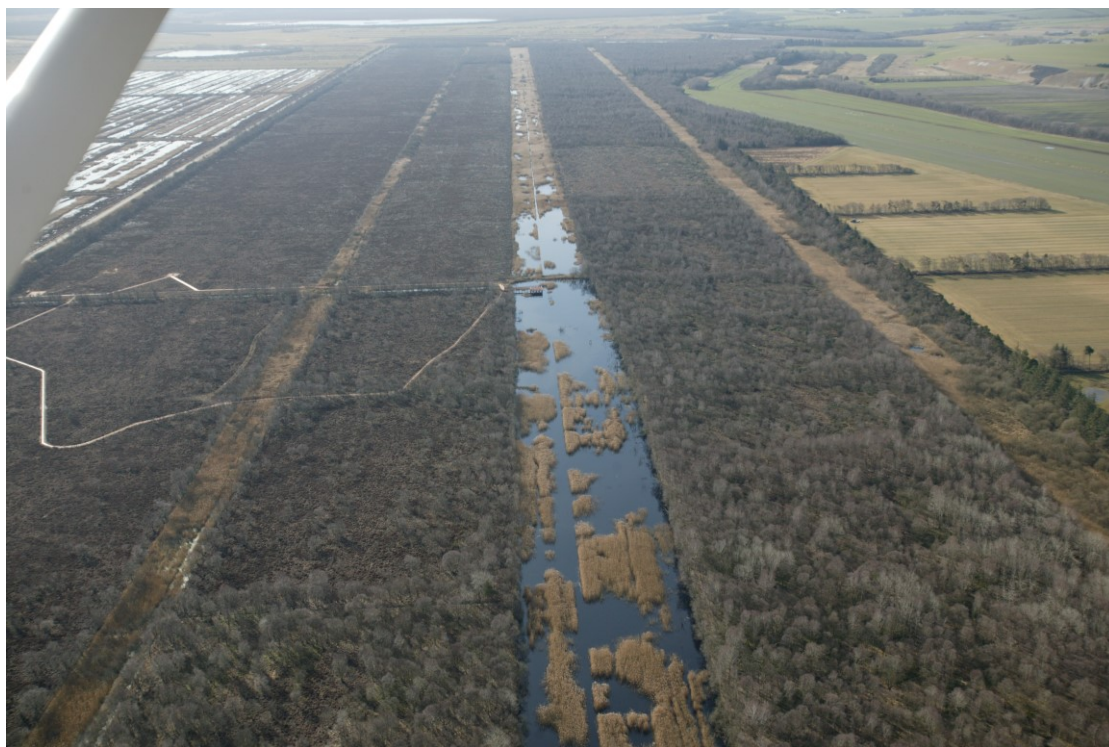
Photo showing Portlandmosen (from North to South) before initiating cutting activities

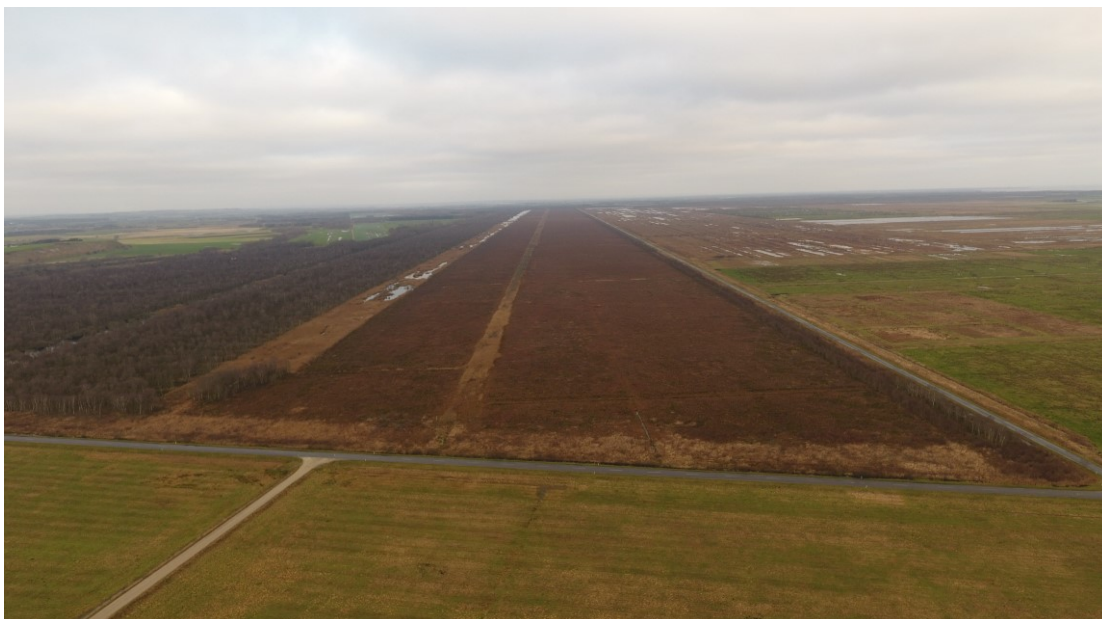
Photo showing Portlandmosen (from South to North) after finishing cutting activities

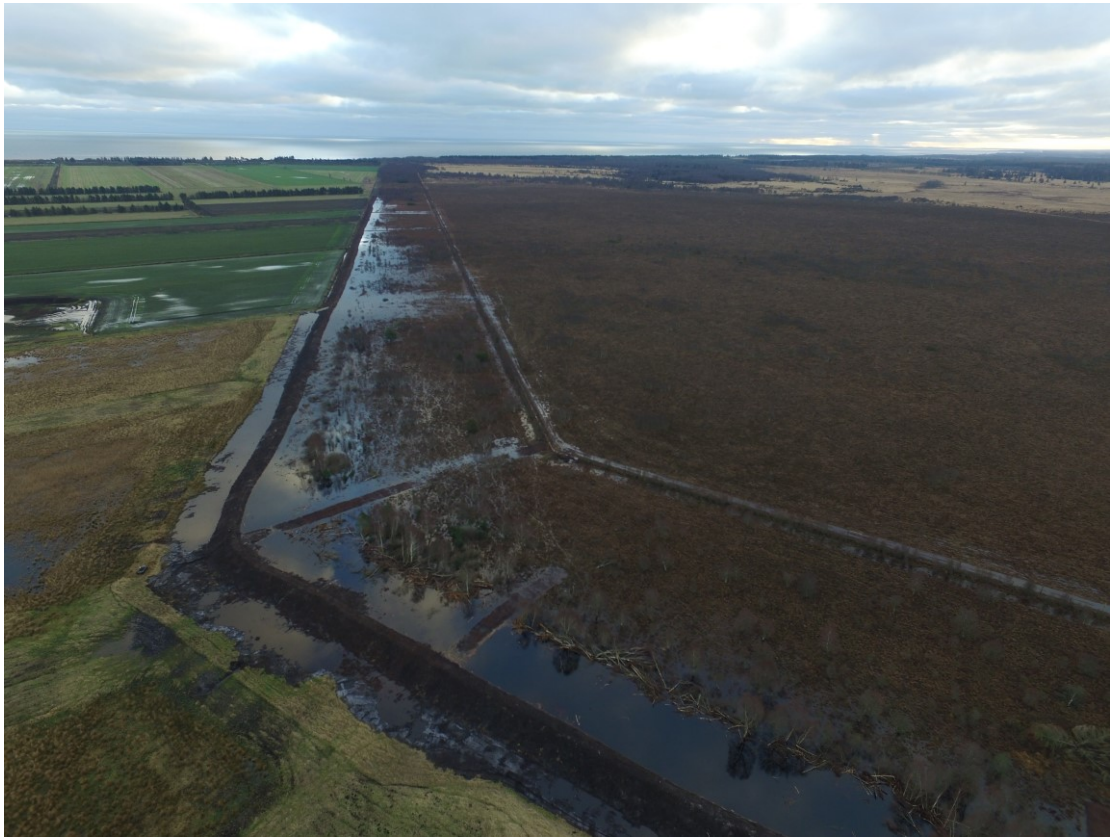
Aerial photo of dike along the edge of Tofte Mose

The aerial photo shows the result of the dike, leading to an immediate raised water level of 30-40 ha on the bog-side of the dike.

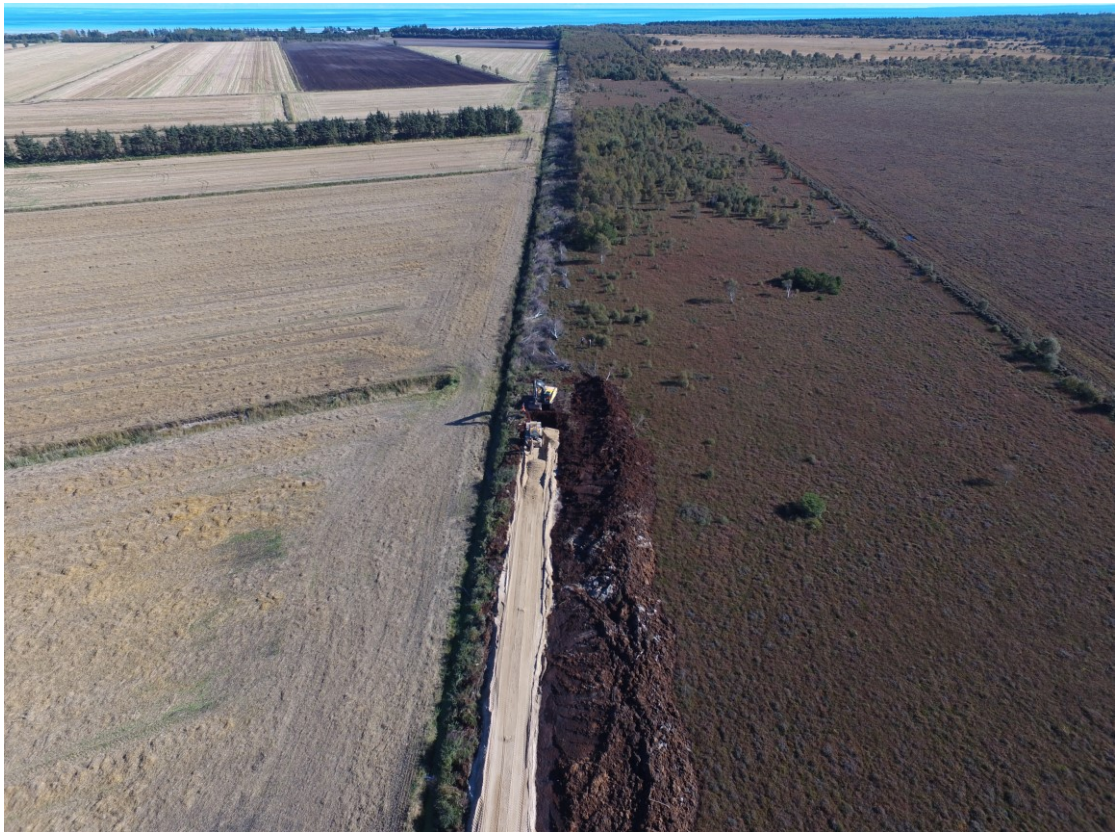
Due to the wet conditions in the bog, it was necessary to construct a temporary road for the dumpers and excavators to drive back and forth along the dike. The mineral soil used for the temporary road was simultaneously used as material for the dike to keep the membrane in place. All in all 14 m³ of mineral soil was used per running meter of dike.

A temporary road was needed during the construction
 Damming up water along a 1500 meters stretch, resulting in 30-40 ha of open water on the bog-side of the dike, increased the risk of creating a continuous flow of water along the dike a the downstream direction. To halt the water flow, small peat dams were built perpendicular to the large dam into the bog.

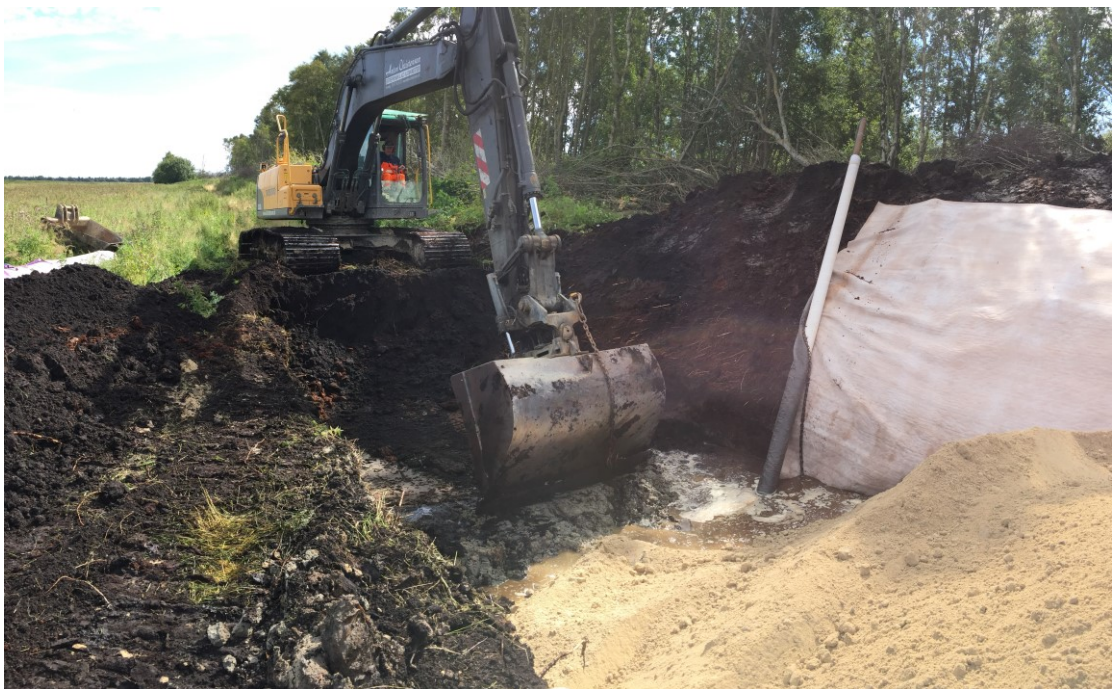
Photo showing the watertight bentonite membrane ready to be covered and kept in place by the mineral soil.

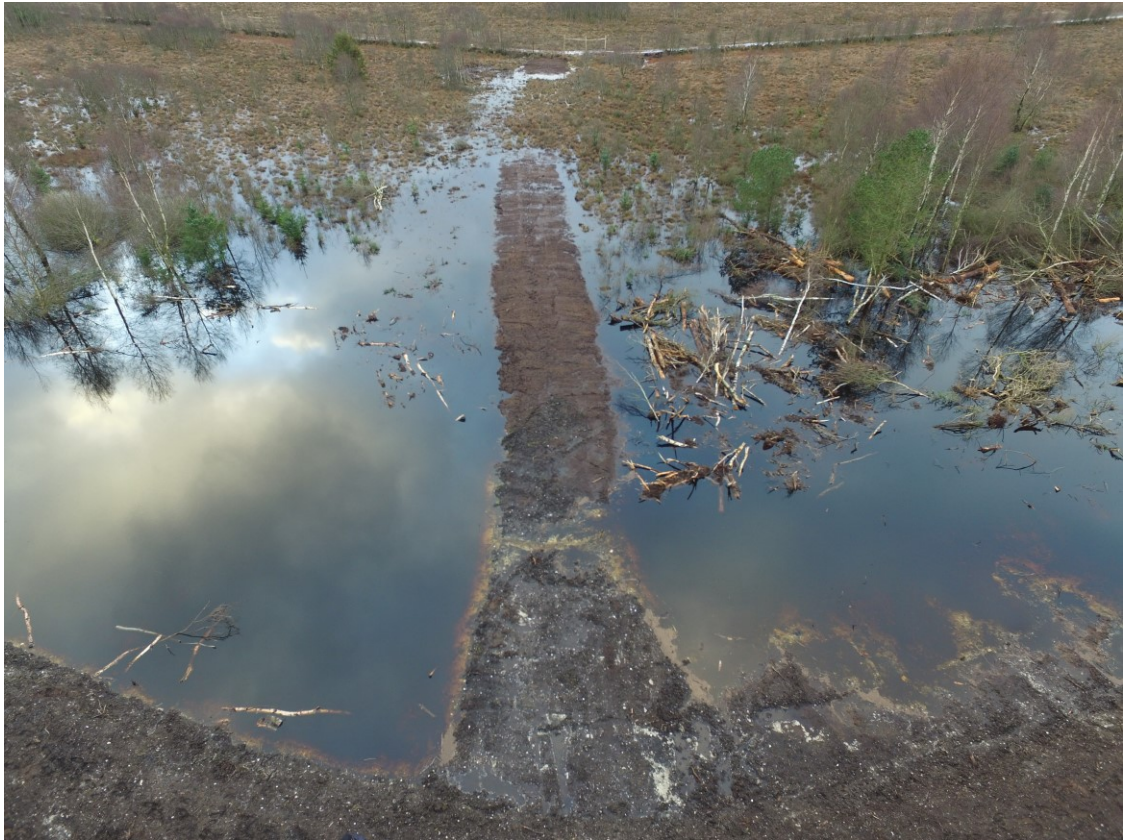
Photo of small perpendicular dam.

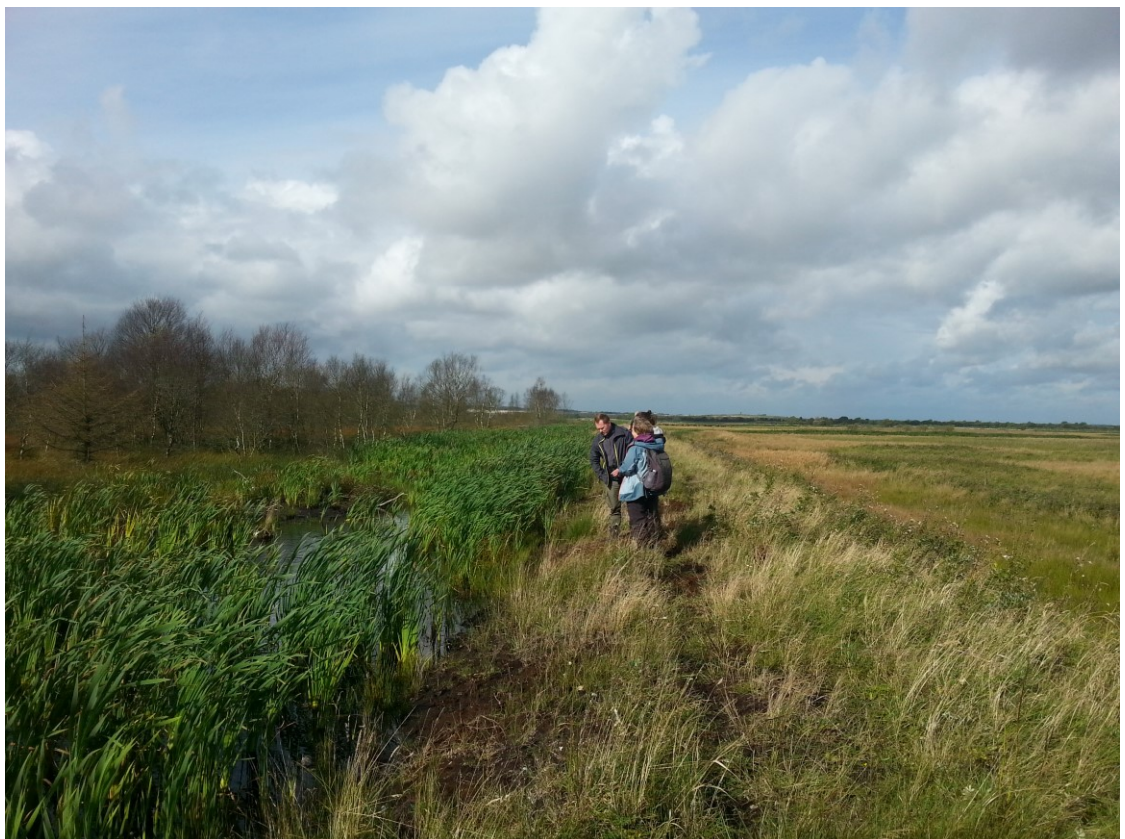
After 1½ years the areas of open water were covered by vegetation.

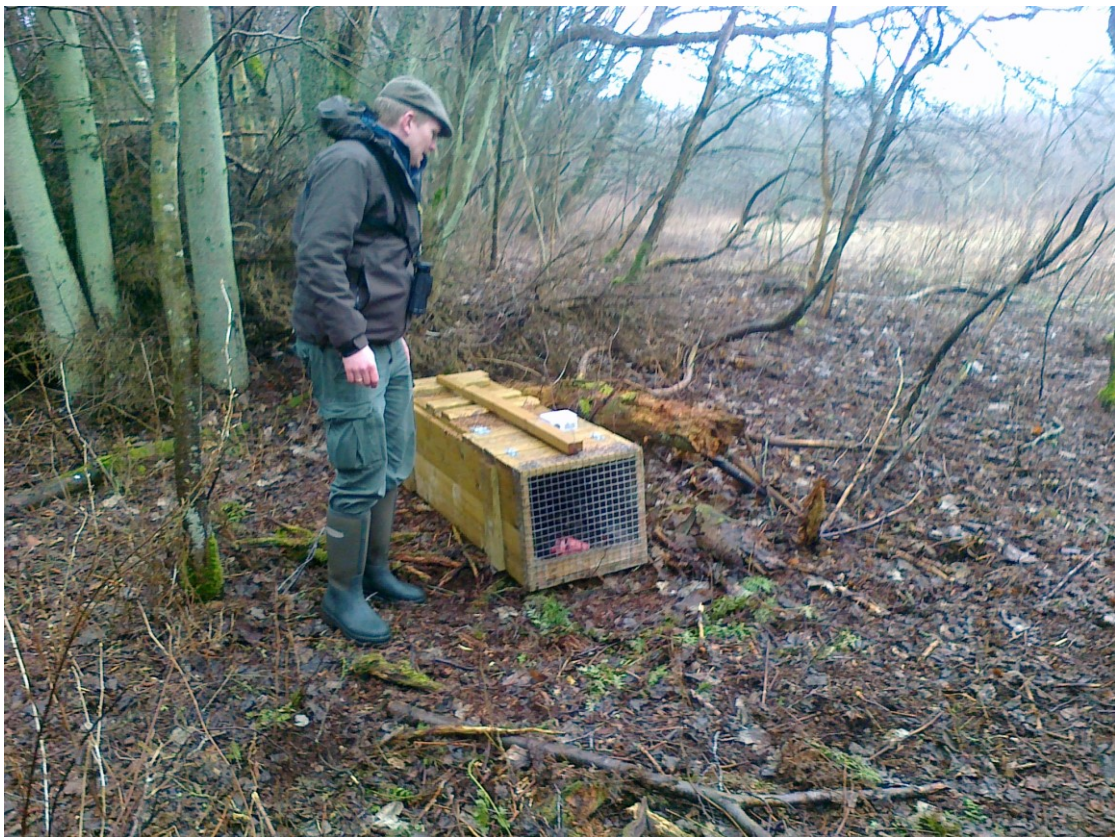
20 wooden traps were built and mounted with sms-modules and placed in the project area, where the carnivores were expected to pass by. Personnel from AVJF has been checking up on the traps, checking the bait on a weekly basis and the signal from the sms-modul every day and checking the traps when the traps were triggered.

Wooden trap with sms module

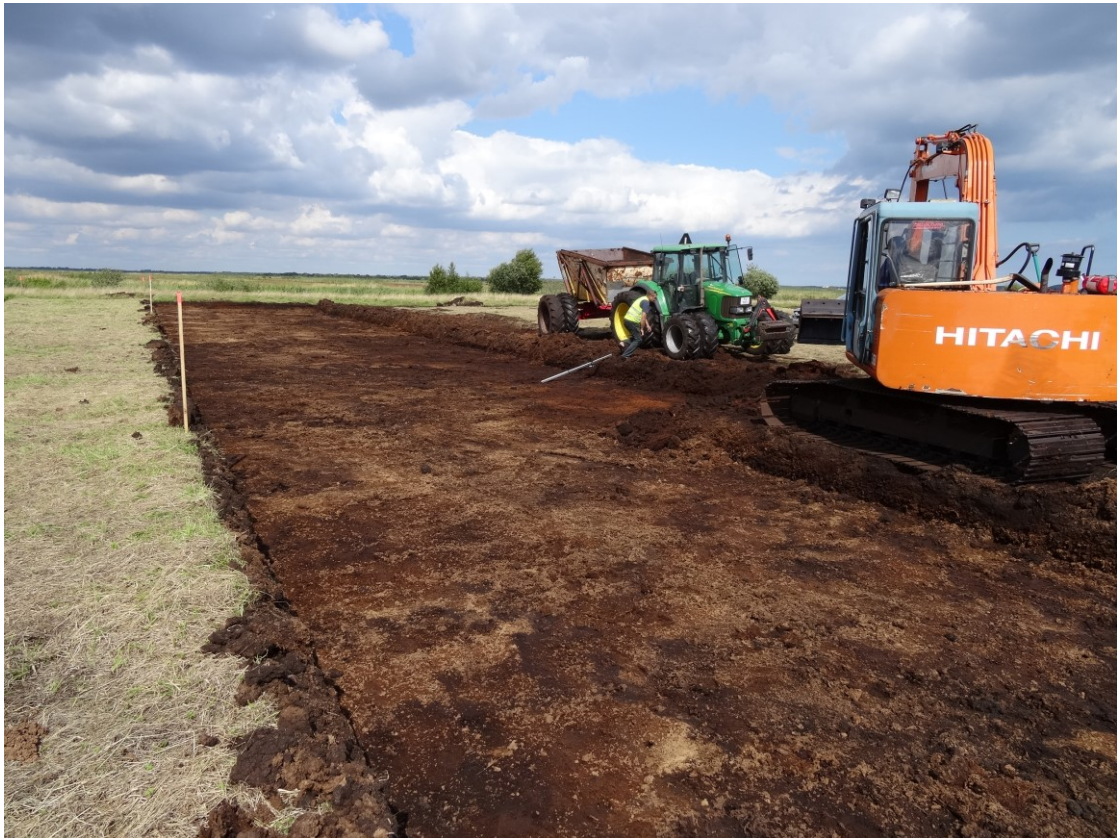
Construction of demonstration site

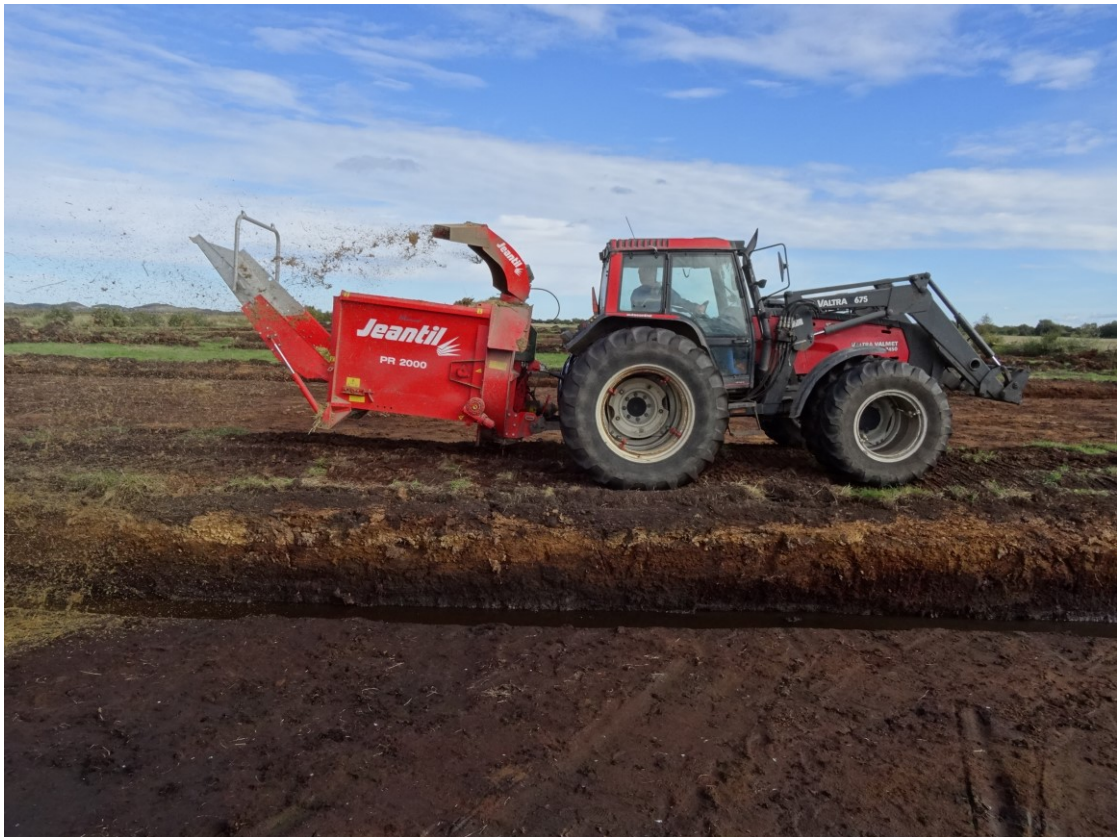
Spreading of sphagnum on demonstration site

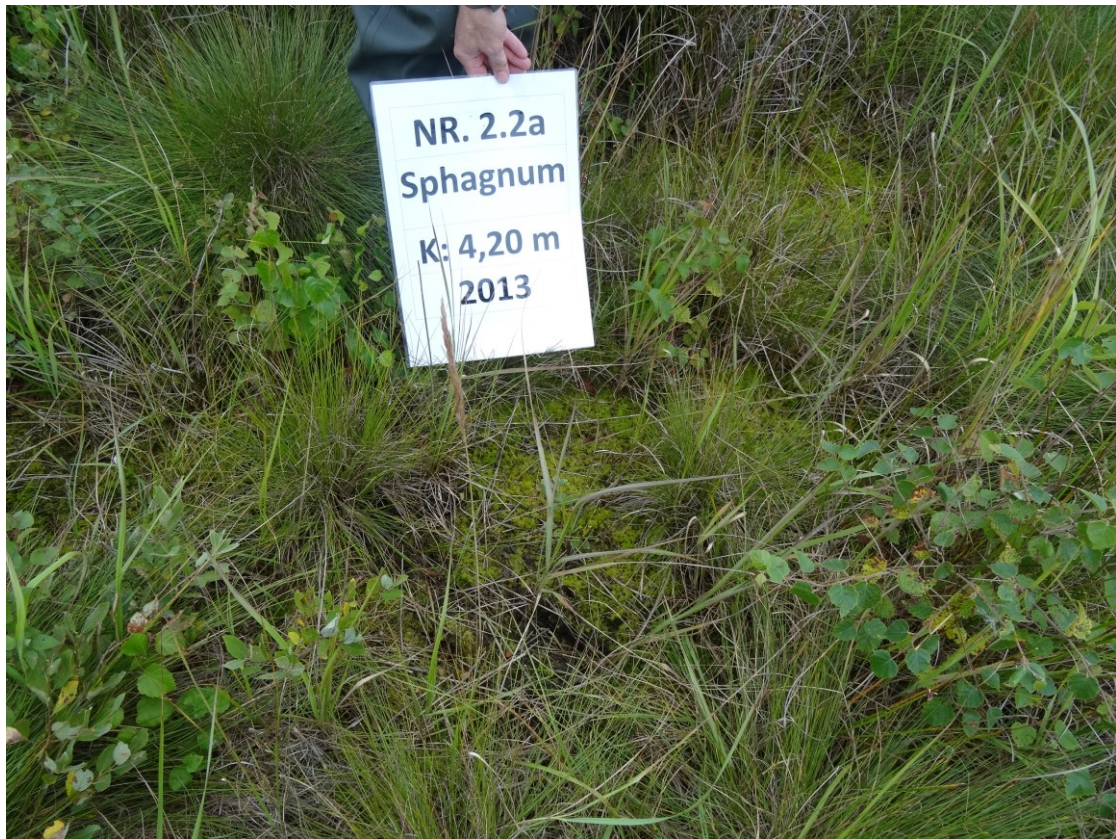
Photo of area with sphagnum growth

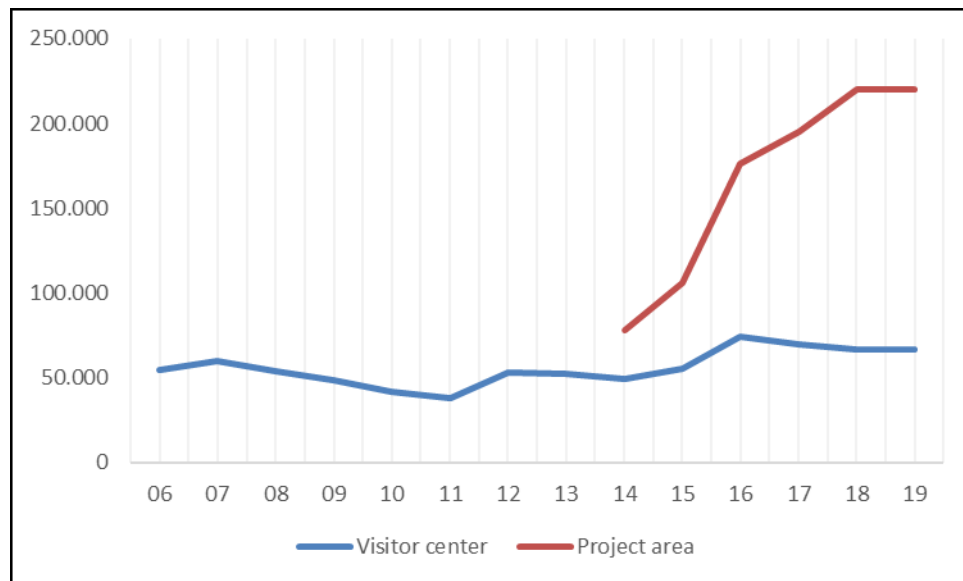
The figure below shows the development in visitors to the project area in Lille Vildmose as well as paying visitors to the visitor centre over. The counting of numbers of visitors to the project area was initiated in 2014 while there exists data for visitors to the visitor centre back to 2006. It is without doubt that the LIFE project and the improvement of nature conditions has increased the interest from the public. Especially the restoration of Lake Birkesø, the public facilities and the large grazing project have had a lot of attention from the public and the number of visitors has increased significantly over the years as a direct result of the restoration project. The steep increase in number of visitors from 2015 to 2016 is without doubt due to the high interest on the large herbivores introduced to Mellemområdet – specially the moose.
