After-LIFE Conservation Plan

Holmegaard Mose

LIFE08 NAT/DK/000466

31/03/2014

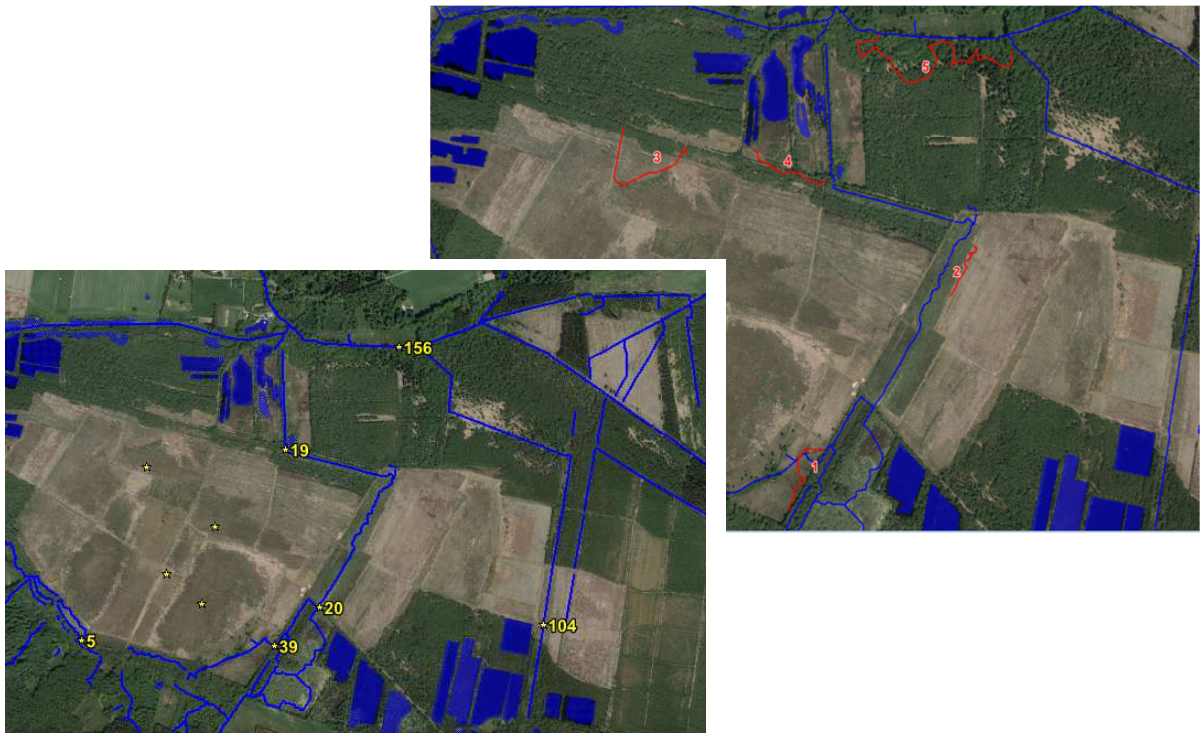
Figure 6 – Assessments of the nutrient impact. Upper map reflects the spread of reed and other plants indicative of presence of calcium or nutrient in the bog. The red lines shows actual fronts of reed. Lower map presents the amounts of inorganic nitrogen (micrograms / liter of ammonium, nitrate and nitrite) present in water samples taken from streams and ditches that flows through and around the raised bog.

Secondly, the load of nutrients in the minerogenic water was measured at selected places after implementation of the hydrological effort. As indicated in figure 6, the water that flows through the central part of the bog still carries nitrogen several times over what might be considered a background level in the lag zone beneath Fensmark Wood (19 – 39 micrograms inorganic N / liter as compared to 5 micrograms / liter).

The threat, which was described in section 2.2.4, is already materializing to some extent, as shown in upper map of figure 6 and by photos from the site, figure 6. The perspective of this development is, that the foreseen growth in the targeted habitat type *7110 *Active raised bog* will be replaced by development of other habitat types or non-habitat nature. In the upstream part of the affected area a few hectares of degraded bog during the project period has actually developed into alkaline fen, which by continuing influence of nutrients may develop further to a non-habitat type.

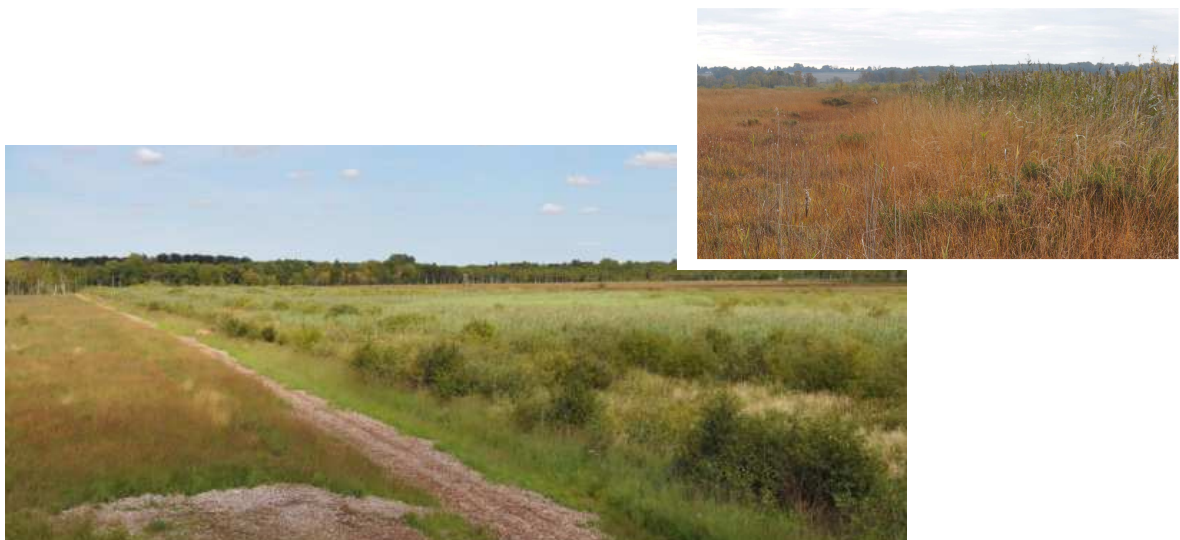
Figure 7 – The raised bog is cut through by two crossing streams. This photo shows the minerogenic and eutrophicated zone along the broadest stream, which was elevated as an element of the LIFE project. The zone has a width of 100 – 250 m. Upper right photo shows the front of reed along the minerogenic stream that was observed to expand during the LIFE project period, as an indication of influx of enriched water into the peat.

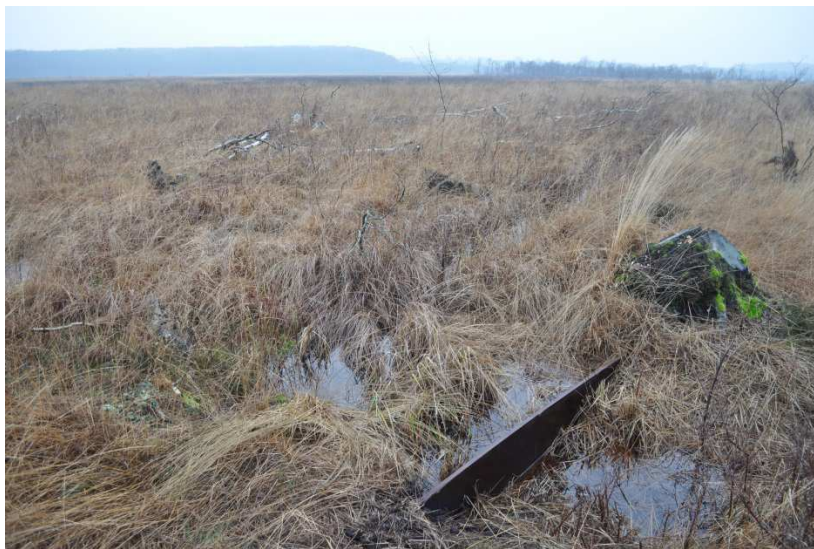
Figure 10 – Blocking of an old drainage ditch in the western part of the bog by a manually inserted plywood plate, December 2013. The actual difference in water level on the two sides of the plate was measured to be 12 cm .

A part of the LIFE project was blocking of drainage ditches in the western part of the bog (figure 10). The ombrotrophic water is the bogs own water with the right chemical constitution, and retention of this water should be the most important thing of all. The action implies a detailed examination of the three remaining raised bog fractions in order to seal as many leaks (drainage ditches, desiccation fractures etc.) as possible.

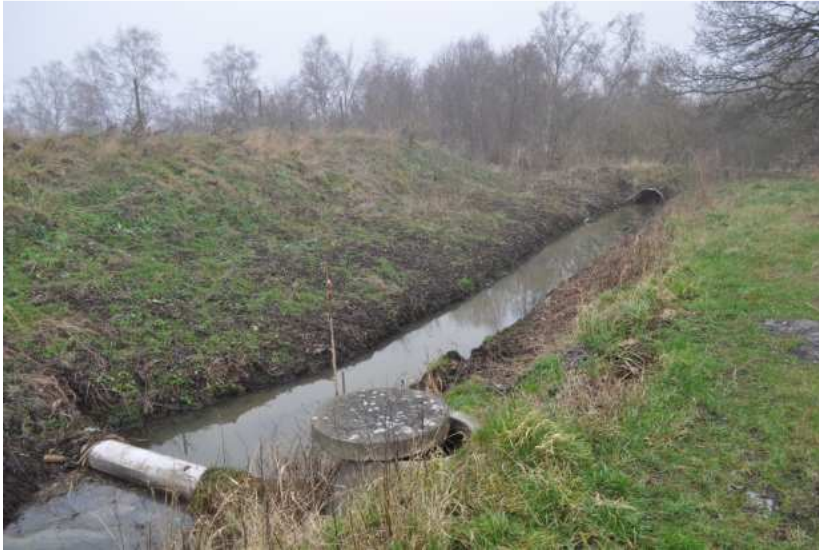
Figure 11 – The eastern part of the bog still receives overflow water from areas with combined sewer systems.

In parallel to what has been realized in the catchment of the western stream, i.e. irrigation of the meadow south of the raised bog, it may be a relevant option to purify the water that feeds the easternmost stream (figure 11), especially if it would be preferable to maintain an ongoing but modest flow through the bog. However, this has to be enlightened by further monitoring of the hydraulic conditions.

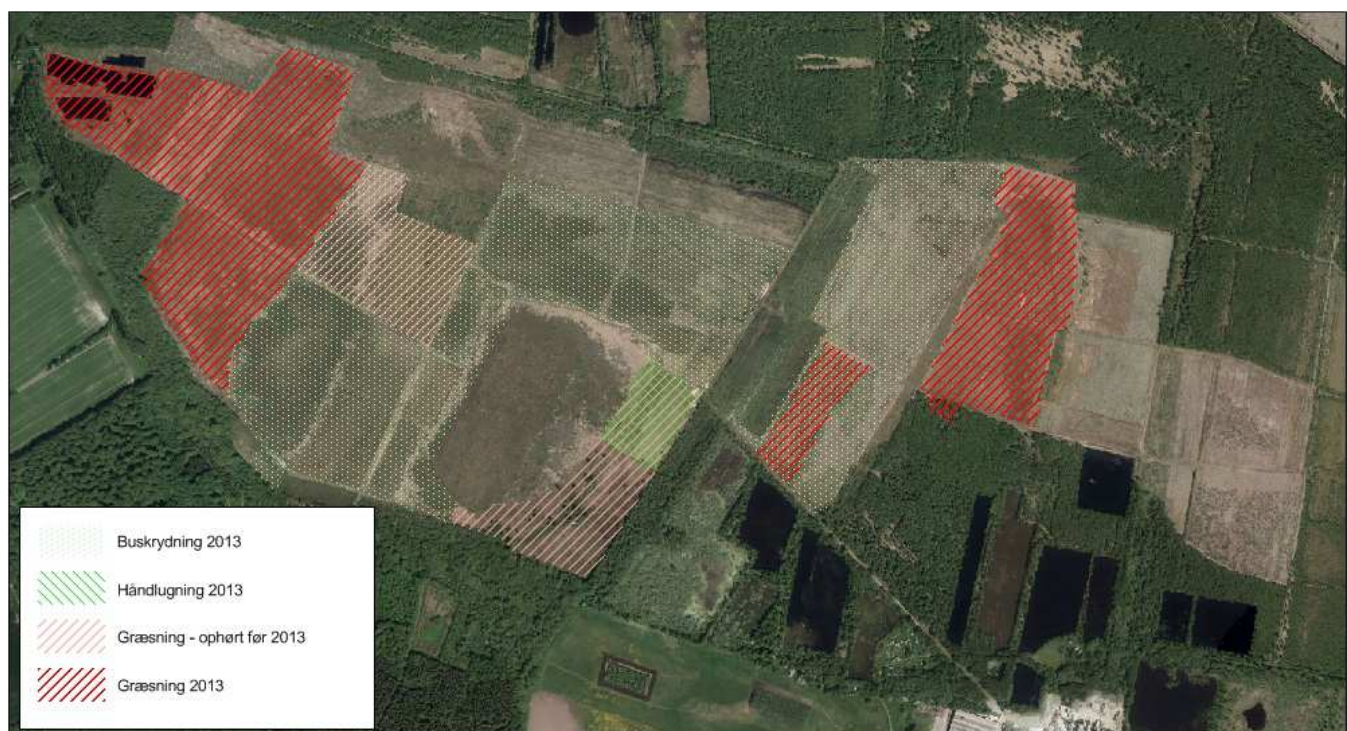
Figure 12 – Management regime in Holmegaard Mose.

Pink shading: Grazing areas where grazing seized before 2013. 13,1 hectares

Red shading: Grazing areas in operation 2013 and further on. 31,0 hectares

Green shading: Manual weeding 2013. 2,2 hectares

Green dotting: Bush clearing 2013. 50,3 hectares

However, in the spring of 2013 a cooperation with Næstved Municipality came into action concerning a labor program called “utility activation”. Unemployed citizens were referred to useful tasks in the public sector as a prerequisite to receive benefits. From the beginning of June and until November a number of citizens involved in this program took part in the management of the raised bog. This concept has played a major role in the actual re-revision of the management strategy (figure 12).

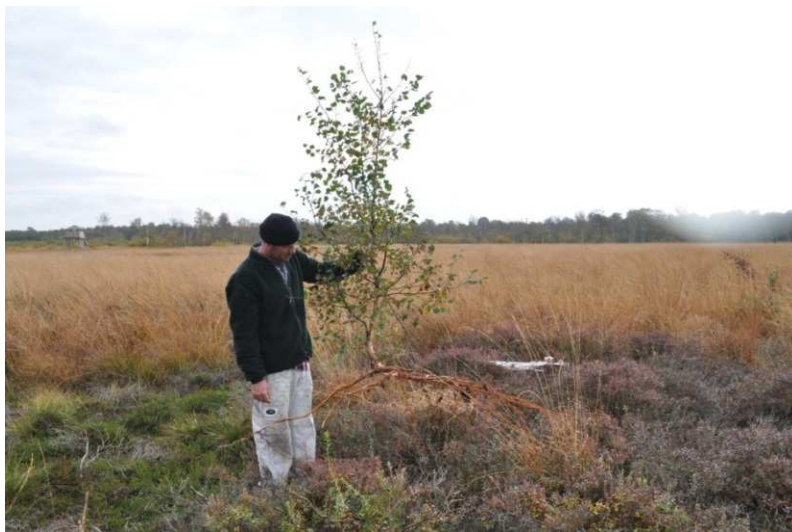
Figure 13 – Even fairly large birch trees can be uprooted from the soft peat soil by hand. However, this is only possible if the trees have not previously been cut down, because the root of the trees that are cut down will have developed a firmer rooting in the substrate.

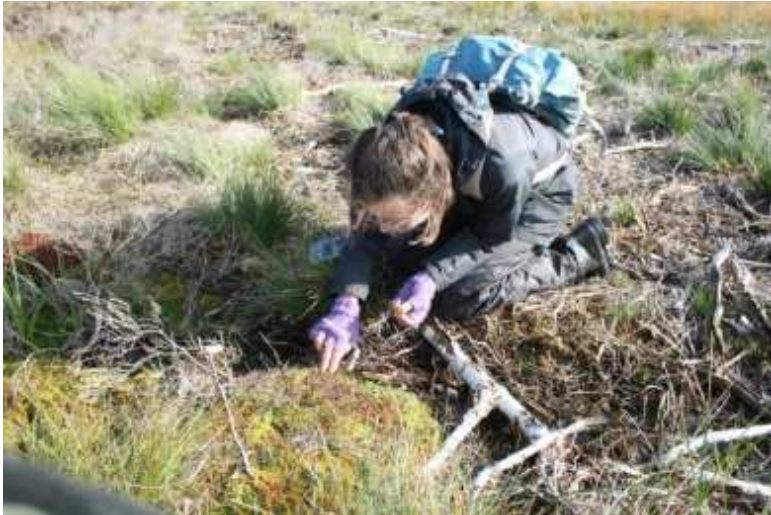
Figure 14 – Examining a peat moss. A pillow of live moss have started to grow on the exposed surface of dead peat moss where there used to be birch forest.

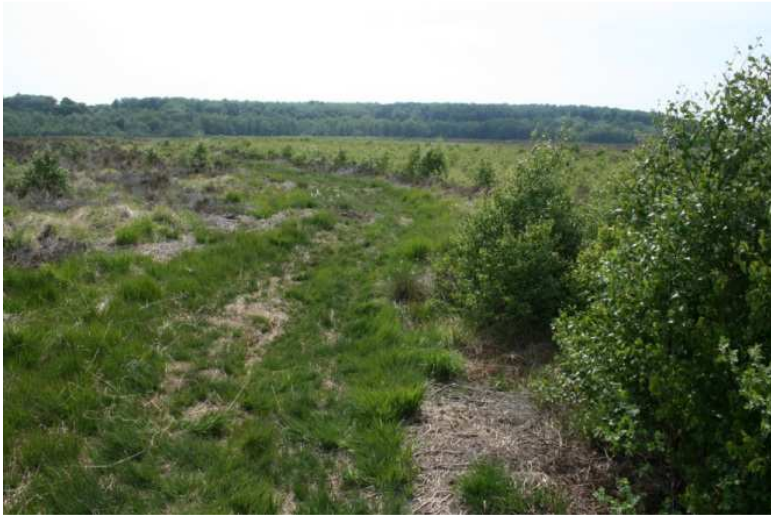
Figure 15 – Dense regrowth of birch in an area, where former clearings have been followed by too extensive management.
