RERABOG Progress Report 2008

Annex E

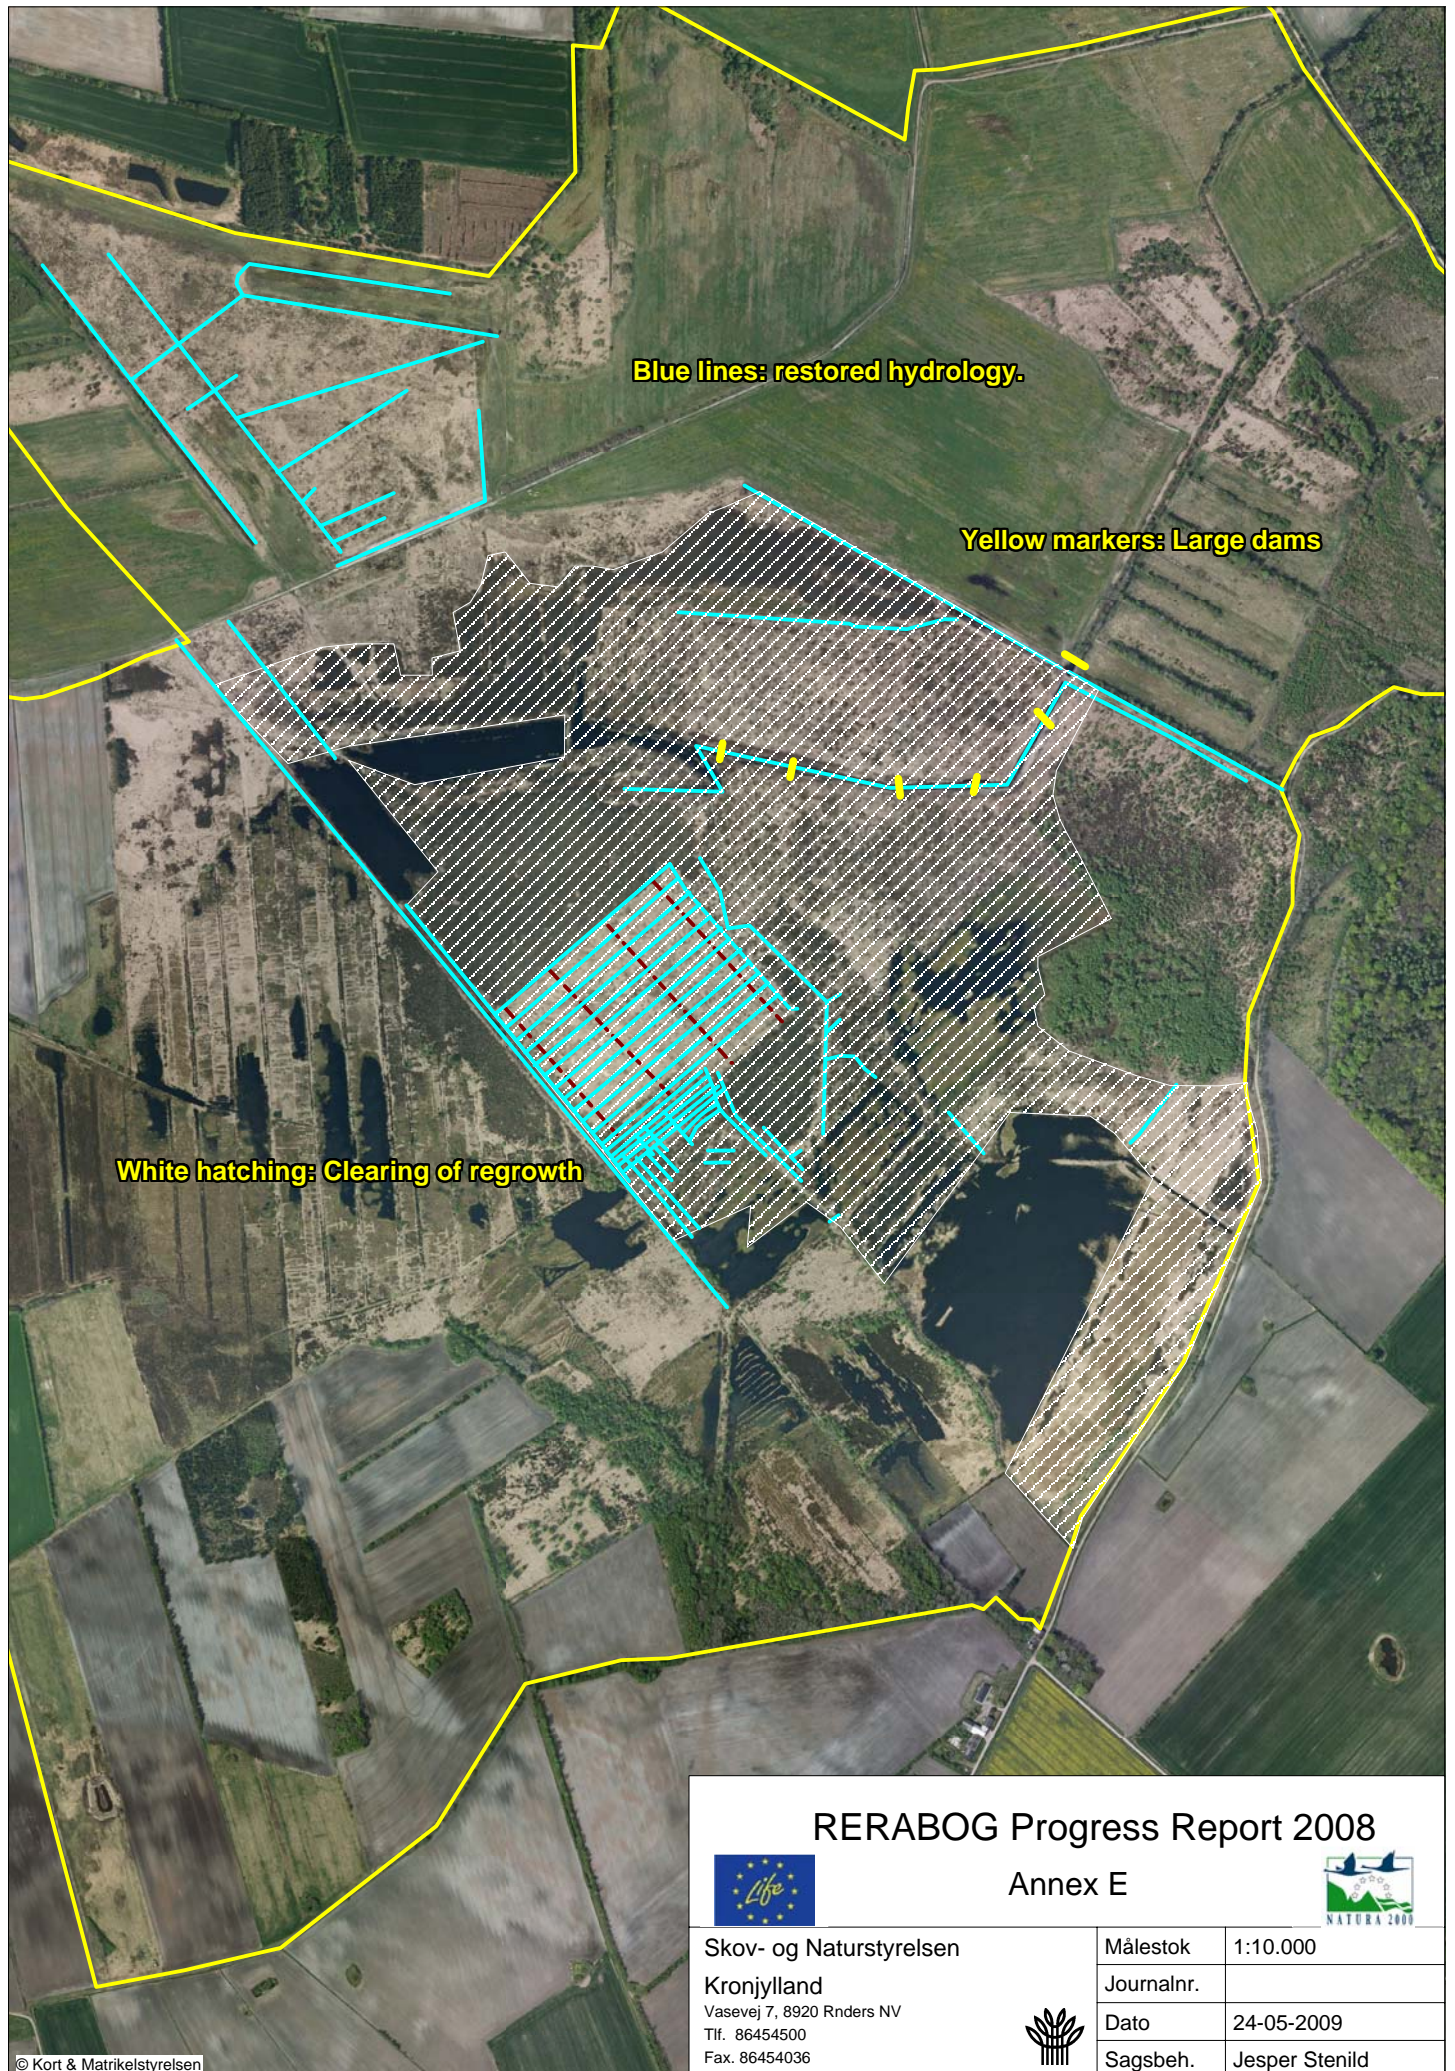
Blue lines: restored hydrology.

Yellow markers: Large dams

White hatching: Clearing of regrowth
